# **NL Journal of Dentistry and Oral Sciences**

**Case Report**

# The Challenge of Retrofitting A Survey Crown to an Existing Partial Denture

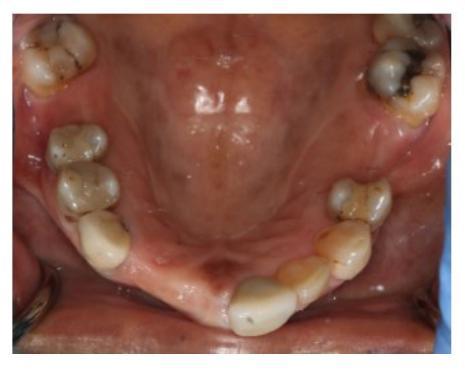
Figure 2: Occlusal pictures of patient's initial condition without RPD.

Extra-oral examinations revealed crepitus in the temporomandibular joint. Patient reported no pain in the area or limitation to range of motion. Intra-orally, all soft- and residual hard-tissues were within normal limits. The patient is a Kennedy class III [12] at sites of teeth number #3, #7, #8, and #13. The RPD was well designed and adapted to the rest seats of teeth number #2, #4, #12 and #14 (Figure 2 and 3). A full mouth radiograph series was taken, and a comprehensive clinical evaluation was performed. The patient's periodontal diagnosis was Stage IV, Grade A periodontitis [14]. Clinical findings evidenced defective restorations as well as caries on teeth number #2, #4, #5, #12, #18, #19, #10 and #20 (Table 1).

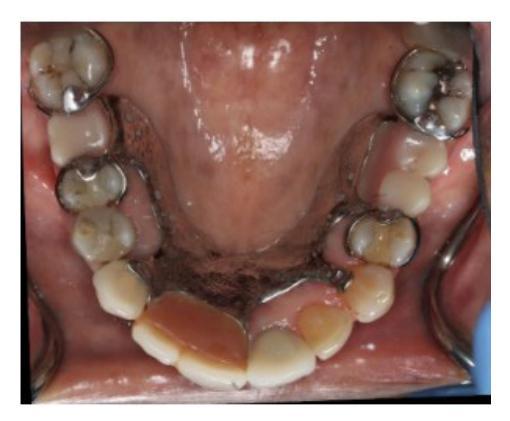
Figure 3: Occlusal pictures of patient's initial condition with RPD.

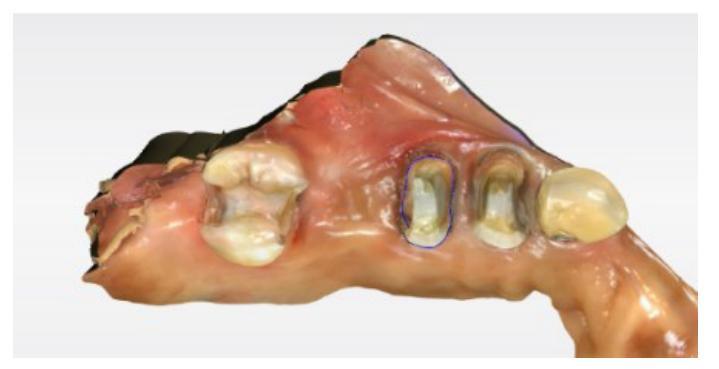
Figure 4: Digital model of the preparations of teeth #2, #4, #5

Preparations were completed using a rounded-end tapered diamond bur (Komet USA, Rock Hill, SC). Minimally invasive preparations of teeth number #2, #4 and #5 (Figure 4) allowed the preservation of sound tooth structure on the lingual area of the premolars and both buccal and lingual cusps of the molar. Tooth number #12 was planned for a full coverage restoration. Once finished, a retraction cord (Ultrapak; Ultradent, South Jordan, UT) was placed intrasulcular around each preparation.

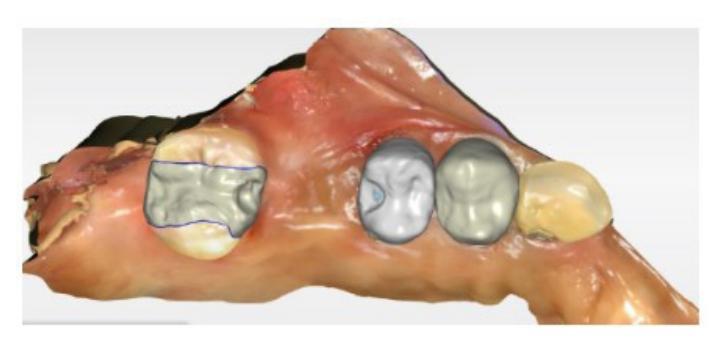
**Figure 5:** CAD CEREC's " biogeneric copy" of the initial abutment teeth morphology.

A scan of the prepared teeth was taken, and the restorations were digitally designed using the preoperative scan data, mimicking each tooth contour prior to the preparation (Figure 5). When all CADs were completed, the restorations were milled out of LD ceramic blocks (E-max, Ivoclar/Vivadent, Somerset, NJ) using a milling machine (MCXL; Dentsply/Sirona, Charlotte, NC).

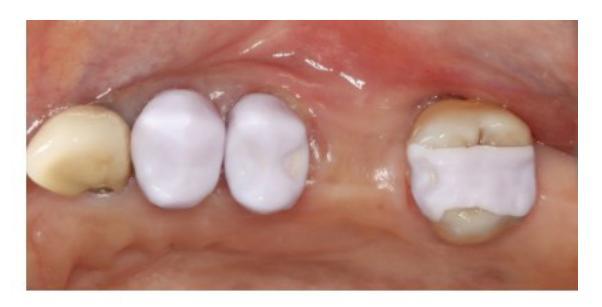
Figure 6: Intra-oral fitting check of Inlay (#2) and partial crown (#4, #5) of LD in purple stage.

The blue-phase e-max onlays had the sprues removed and were tried into the patient's mouth (Figure 6). After verifying all clinical and radiographic adaptations, the patient's RPD was seated to ensure the onlays and crowns were retrofitting properly (Figure 7). The blue-phased e-max were polished (Dialite LD; Brasseler, Savannah, GA) and fired at the oven (Programat CS, Ivoclar/Vivadent, Somerset, NJ) following the manufactures' recommendations.

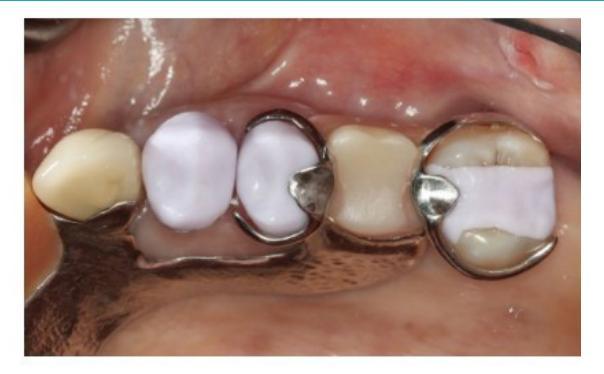
Figure 7: RPD clinical seating assessment over purple stage LD crowns.

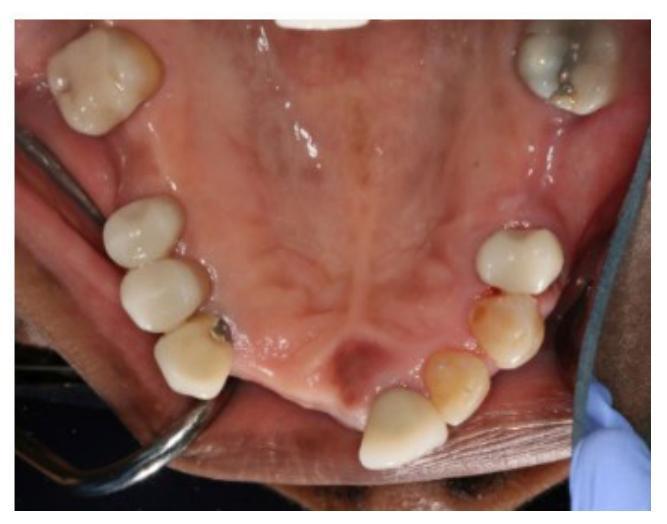
Figure 8: Occlusal view pictures of patient's final condition without RPD.

The completed onlays and crowns were cemented using resin-based adhesive cement. The intaglio surface of each restoration was etched for 20 seconds using hydrofluoric acid (Ultradent, South Jordan, UT), rinsed and dried. Monobond plus (Ivoclar/Vivadent, Somerset, NJ) was used as ceramic primer. The enamel of all preparations was etched with 37% phosphoric acid (Dentsply/Sirona, Charlotte, NC) for 30 seconds, rinsed and dried. Universal adhesive ("Adhese" Ivoclar/Vivadent, Somerset, NJ) was actively applied to all surfaces, air thinned, and light cured with a 1,470 mW/cm2 light curing unit (Paradigm DeepCure, 3M Oral Care, St. Paul, MN). Each restoration was cemented separately. Dual-cure resin-based cement (Variolink; Ivoclar/Vivadent, Somerset, NJ) was placed on the intaglio surface, seated in position, and light-cured for 3 seconds. Excess was removed, followed by 40 seconds of light curing exposure. After cementation, the patient was able to try in the RPD, and minor adjustments were made to occlusal contacts and seating, using a fine-grit diamond bur (Figures 8, 9 and 10). All adjusted areas were polished (Brasseler, Savannah, GA).

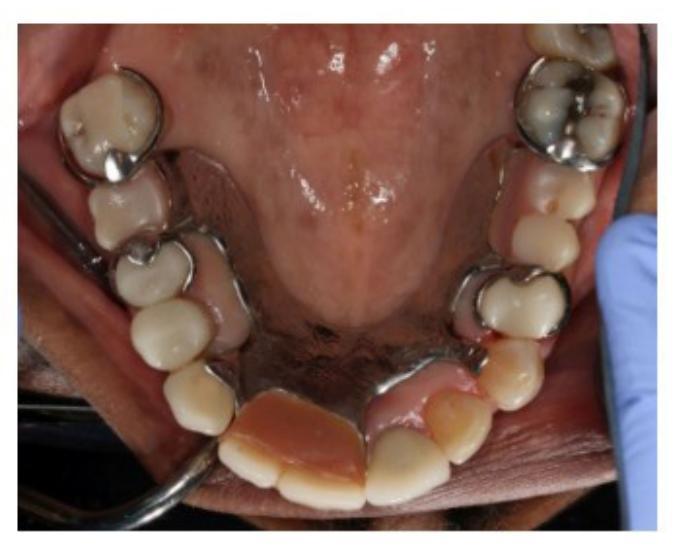
Figure 9: Occlusal view pictures of patient's final condition with RPD.
